logging test of a single-hull BALLOON

By HILTON H. LYSONS
VIRGIL W. BINKLEY
CHARLES N. MANN

PACIFIC NORTHWEST
FOREST AND RANGE EXPERIMENT STATION
U.S. DEPARTMENT OF AGRICULTURE

U. S. FOREST SERVICE
RESEARCH PAPER PNW-30

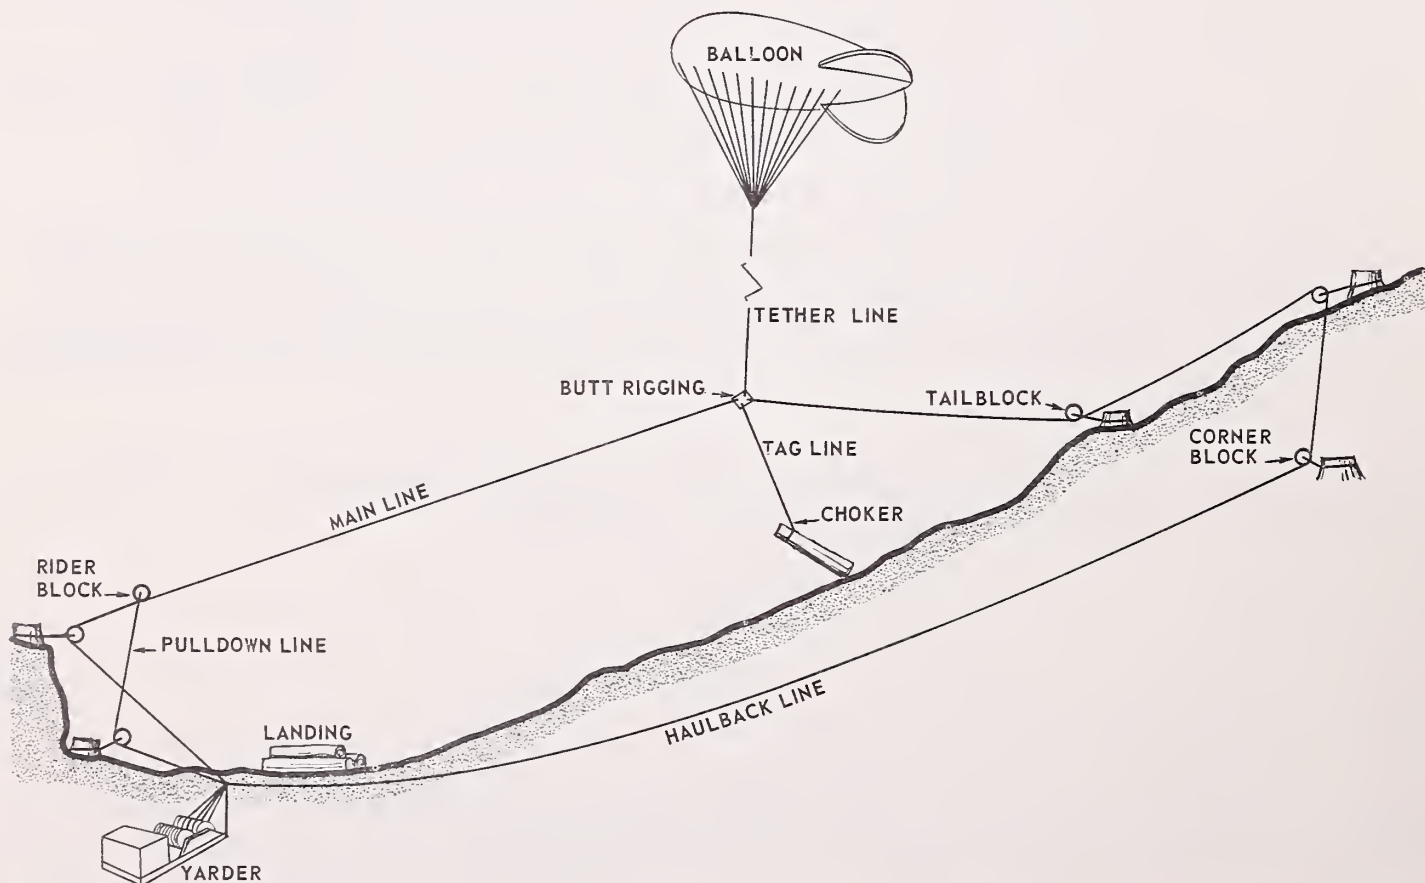
Figure 1.--Arrangement of operational equipment for single-hull balloon test.

Figure 1 shows the arrangement of operational equipment used in this test. The various components are described in detail below.

Rigging.--As shown in figure 1, the rigging was similar to that used in high-lead yarding, except that the balloon tether line was attached to the butt rigging and provided lift at this point. A 1/2-inch-diameter main line and a 9/16-inch-diameter haulback line were used with both yarders. Two 1/2-inch tether lines were incorporated between the butt rigging and the balloon suspension (one as a load line, and the second as a safety line to prevent loss of the balloon in the event of failure of the load line). Tag lines varied from 50 to 150 feet, depending on the terrain and landing areas.

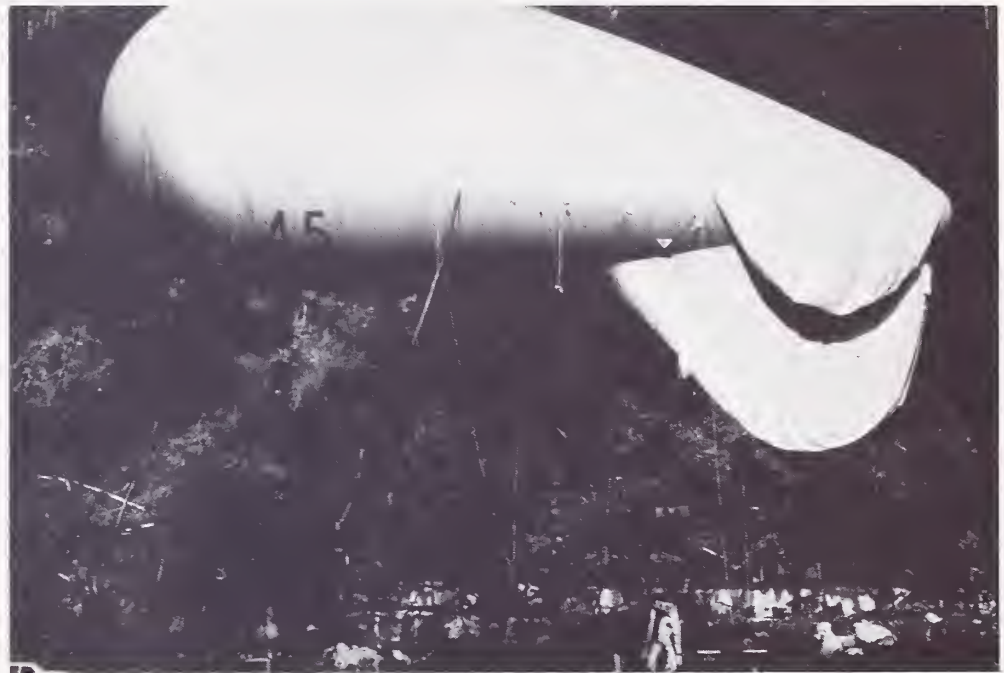
Figure 2.-- Single-hull balloon just after release from bedding ground with tailfins deflated.

Configuration of this British balloon is typical of the majority of tethered balloons. The balloon consisted of a streamlined hull with three inflatable tailfins. A ballonnet, or air-filled compartment, was incorporated in the lower portion of the hull and was separated from the gas section by a diaphragm. Ram-air, which entered through an airscoop, pressurized the ballonnet to maintain the hull shape in wind. The ballonnet also provided a variable hull volume for expansion and contraction of the gas. The tailfins were also inflated by ram-air and could be collapsed for bedding down. The balloon fabric was coated, two-ply, Egyptian cotton. Figure 2 shows the balloon just after release from the bedding ground with the tailfins deflated. In figure 3, the balloon is shown just before bedding down with the tailfins inflated.

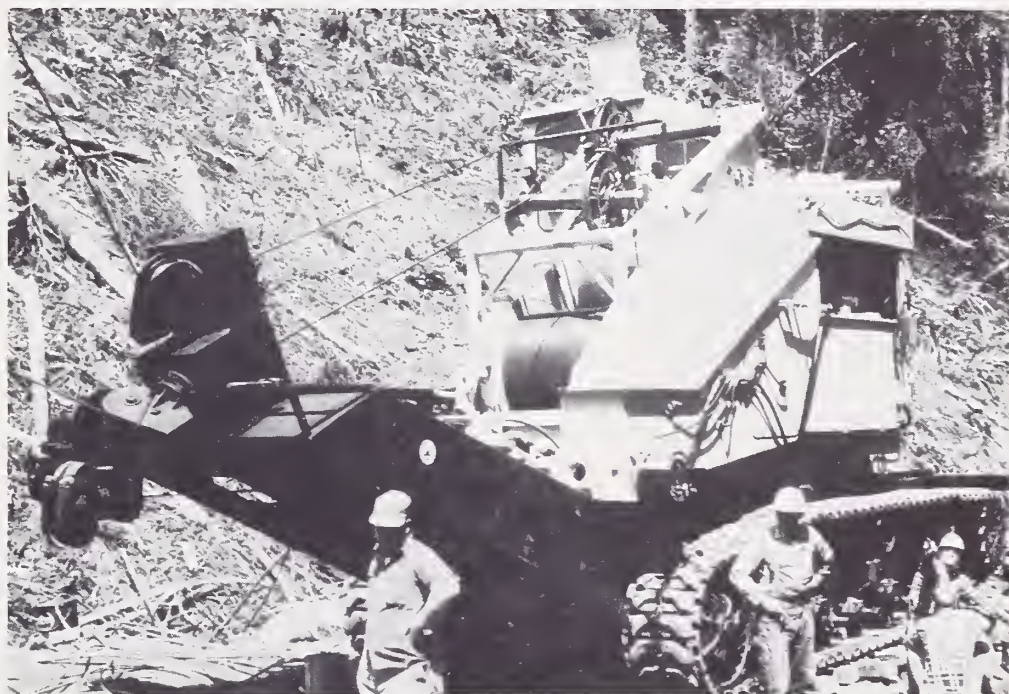
Figure 6.--Tank-mounted balloon yarder, designed and built by Washington Iron Works of Seattle, Washington.

Yarders.-- Two yarders, manufactured by Washington Iron Works of Seattle, were used during the test period. Initially, a modified skyline yarder with a maximum main-line speed of 1,800 feet per minute was used; this was later replaced by a yarder, designed specifically for balloon logging, which had a maximum line speed of 2,500 feet per minute. The skyline yarder is shown in figure 6.

A modified skyline yarder was used during the first phase of testing, and a yarder designed and built specifically for balloon logging by Washington Iron Works of Seattle was employed during the second phase. With the modified skyline yarder, a series of delays occurred due to lines being fouled, stranded, and kinked. When this yarder was replaced by the balloon yarder, time lost for line maintenance was greatly reduced. The 8-hour delay, shown in table 1, on April 30 was required to move the yarder to a new unit.

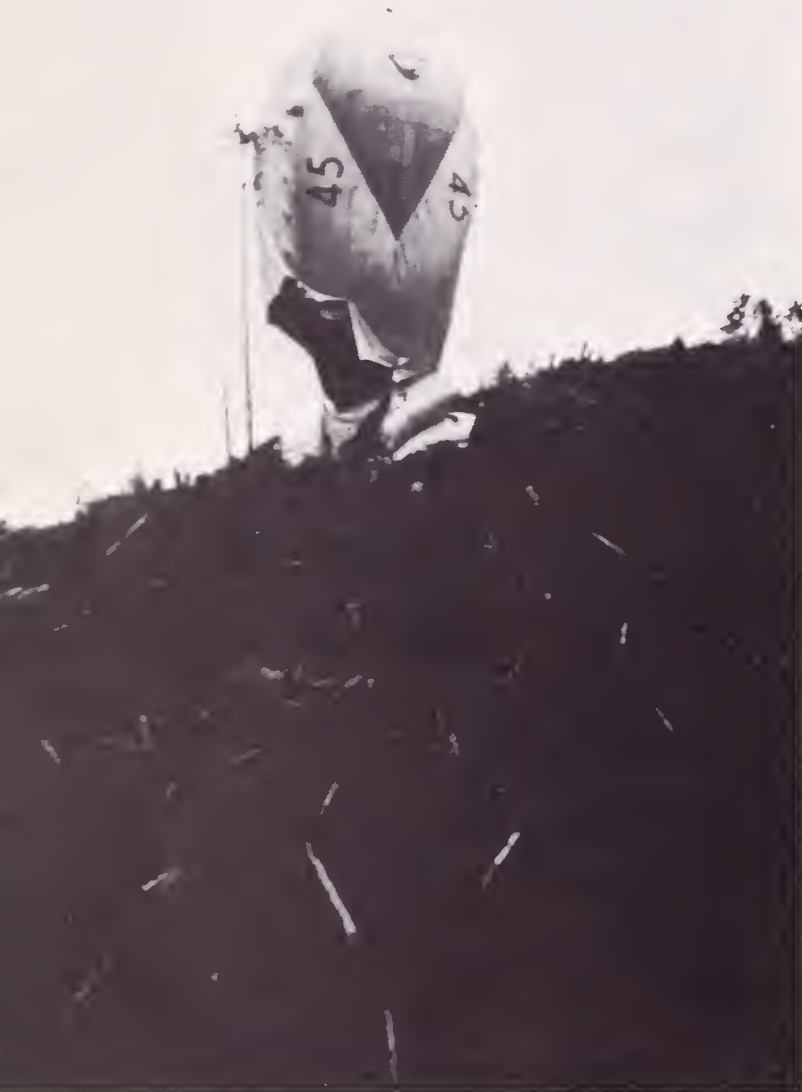
Figure 7.--Single-hull balloon after failure which ended testing.

On May 4, the tail section was torn completely off during yarding. A log, which was being dragged at the time, hung up on a stump. In working the log free with the main and haulback lines, slack was pulled in the tether line. This allowed the balloon to rise freely in a noseup attitude. At the instant that slack was removed from the tether line by the free rise of the balloon, the main line was accelerated by the yarder. A severe impact load resulted; and since the balloon was in a noseup attitude, only the front suspension lines received this load, resulting in a failure of the front suspension lines as well as violent pitching and rolling of the balloon. This motion and the tension in the tether line caused failure of most of the remaining lines as well as one of the suspension line attachment patches. Finally, a patch near the tail of the balloon was torn out, initiating a tear which continued around the entire hull. Figure 7 shows the balloon after the failure. Repair was considered impractical due to the age and condition of the balloon.

The failure, which resulted from an impact load when the balloon was in a noseup attitude, might have been avoided if the suspension cables had not been in a weakened condition due to age and corrosion. Since a noseup attitude will always result when the balloon is allowed to rise freely, and since a suspension system designed for loading in a near horizontal attitude cannot distribute loads evenly when the balloon is in a noseup attitude, loading of this type should be avoided.

This failure occurred during planned severe loading tests and in no way reflects on Bohemia Lumber Co.'s fine performance. The failure proved valuable in that it resulted in the development of a new concept of loading and log lift-off which should prevent such failures and still safely permit the handling of heavier log loads.

It would seem that the old British balloon stood up very well with time and that failure was due to either dynamic loads or to progressive failure of the load lines.

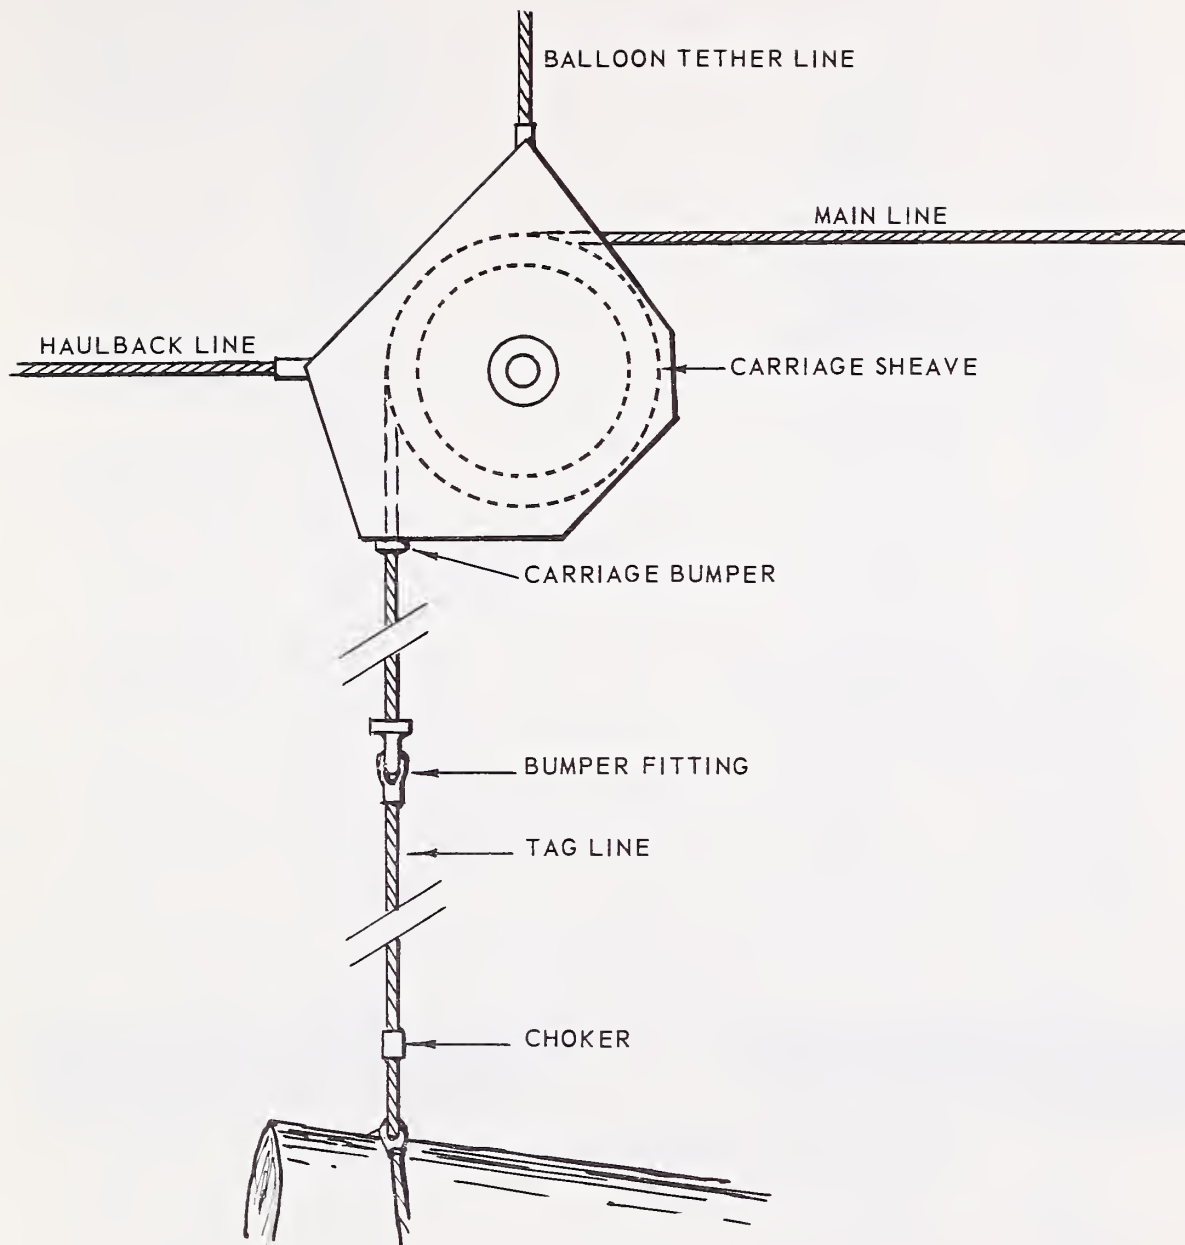
Figure 8.--Balloon logging carriage.

The experience gained in this test pointed out the requirement for a different method of lift-off loading, which led to a new balloon-logging-carriage concept shown in figure 8. Operation is shown in figure 9. After chokers are secured to the logs, the main line is let out, allowing the balloon to rise. When the balloon has reached the desired height, the main line is rapidly pulled in, which induces an upward pull on the logs and a downward pull on the balloon. Motion of the balloon is opposed by static lift, inertia, and drag; and these forces combine to lift the logs. A bumper fitting on the line above the tag line fixes the length of the tag line to facilitate choker setting and log landing. Design and testing is required to develop this concept.

Several problems were encountered with this type of loading. The short duration of the impact load and slack in the main line required precise timing to keep the logs in the air. Drag force limited the free rise velocity of the balloon. The noseup attitude of the balloon, which resulted from the free rise, caused unbalanced loading of the balloon suspension cables. This unbalanced loading destroyed the test balloon.
